TECHNICAL REPORT RL-76-13

2.75-INCH ROCKET LAUNCHER ICE PROTECTION
TESTS, DECEMBER 1975 TO FEBRUARY 1976

Donald Davis
Ground Equipment and Materials Directorate
US Army Missile Research, Development and Engineering Laboratory
US Army Missile Command
Redstone Arsenal, Alabama 35809

18 March 1976

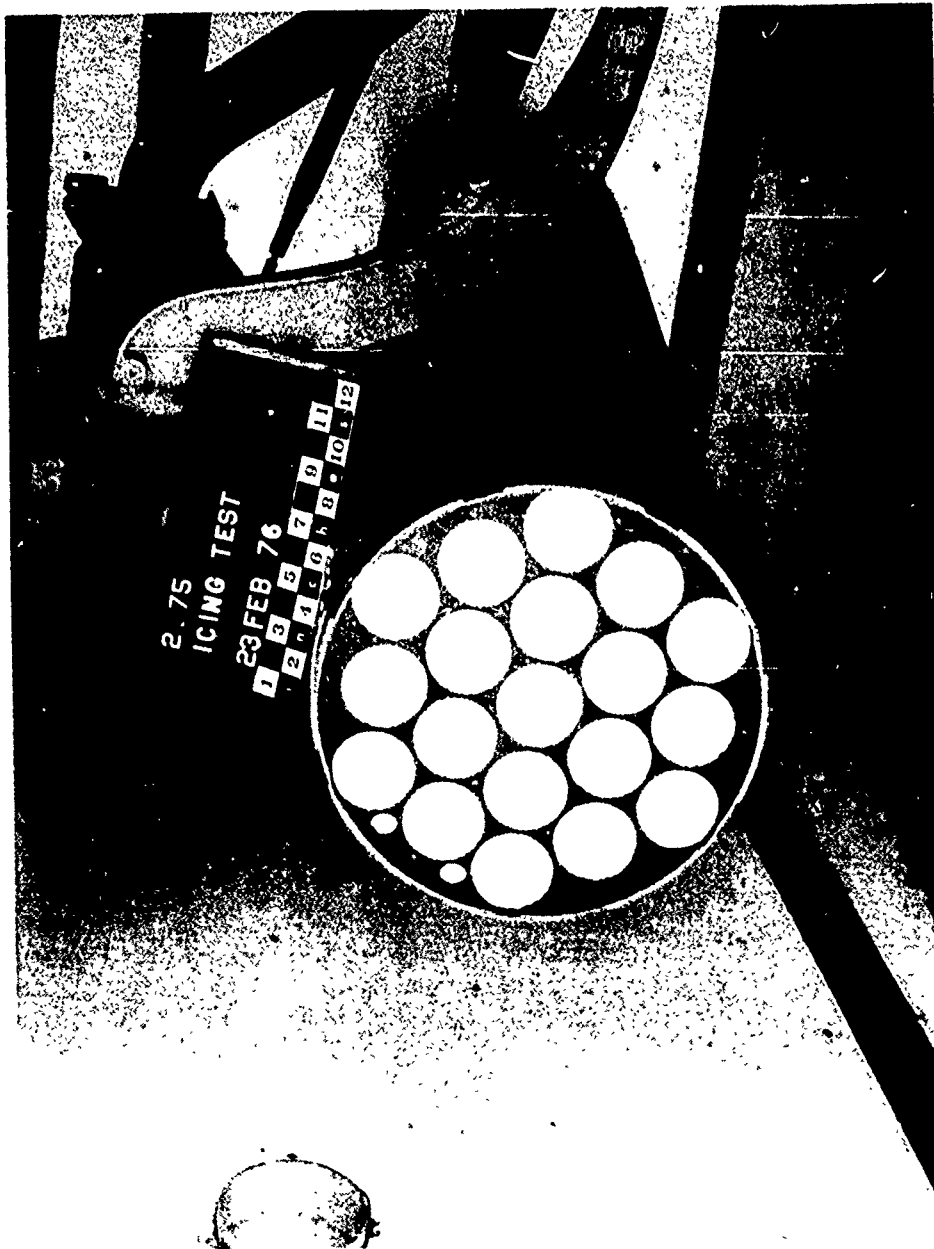
Figure 20. Heater bulkhead installed.

For the final test in this series, the masonite/styrofoam combination was installed on the M200 (Figure 20). One-half inch of ice was applied. Three rockets were loaded and fired.
